September 1, 2004

Final Report

SERDP Pollution Prevention Project 1137

Non-Destructive Testing of Corrosion Under Coatings

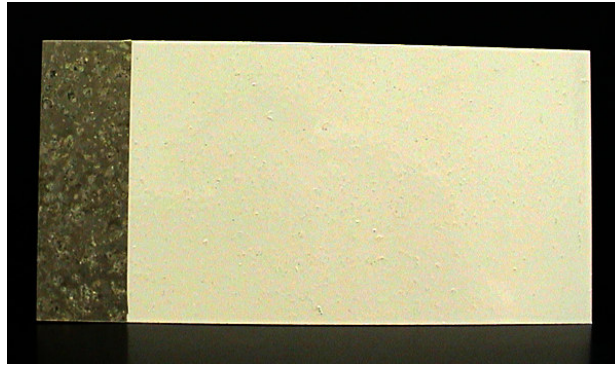
Figure 49 shows a visual image of an un-corroded coupon coated with 3.0 mil primer and topcoat. Figure 50 shows a corroded coupon with a total of 3.0 mil primer and topcoat. Due to coupon roughness, some of the surface morphology comes through the paint. These coupons were imaged in the IR with multiple coats of primer and topcoat.

Figure 50 Visual image of 3.0 mil primer and topcoat on corroded 2024 aluminum coupon.

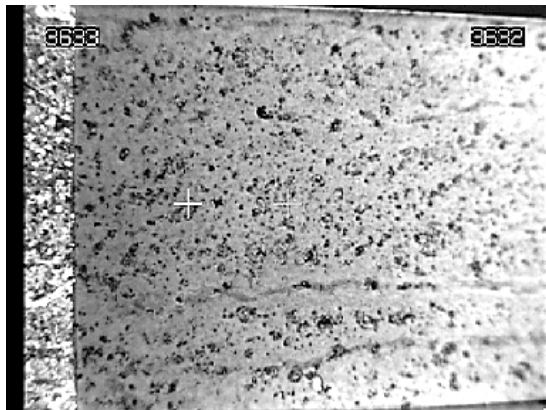
Figure 51 shows the baseline IR image of 3 mil coating on a corroded coupon. The corrosion and pits are readily apparent as observed under IR illumination.

Figure 51 3 mil coating on corroded aluminum. The narrow strip on the left is unpainted

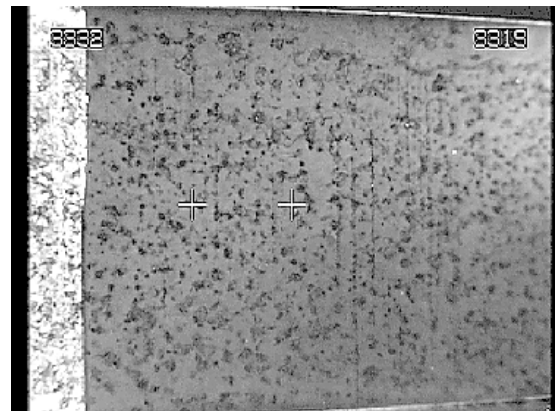
Figure 52 6 mil coating on corroded aluminum. The narrow strip on the left is unpainted

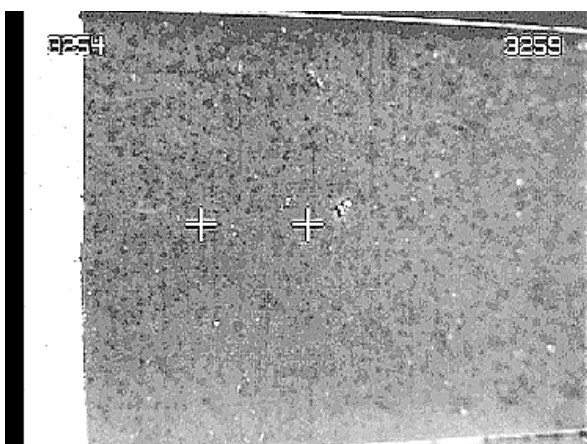
Figure 53 9 mil coating on corroded aluminum.

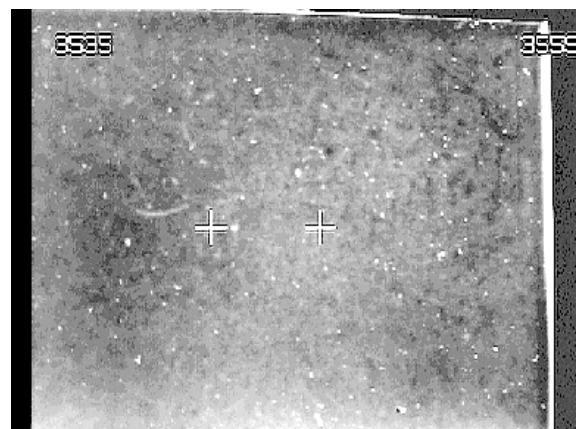
Figure 54 12 mil coating on corroded aluminum

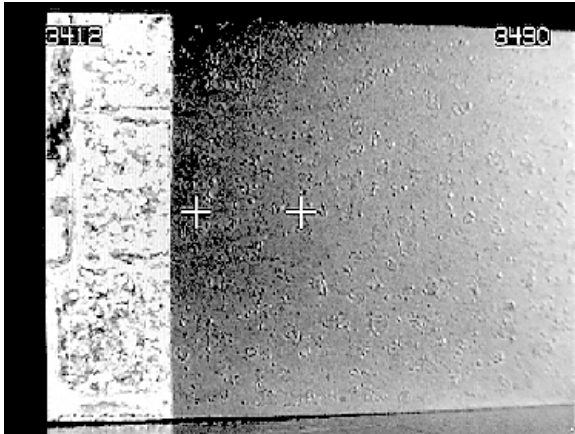
Figure 55 3 mil Dark Camo Grey topcoat on corroded aluminum. The narrow strip on the left is unpainted.

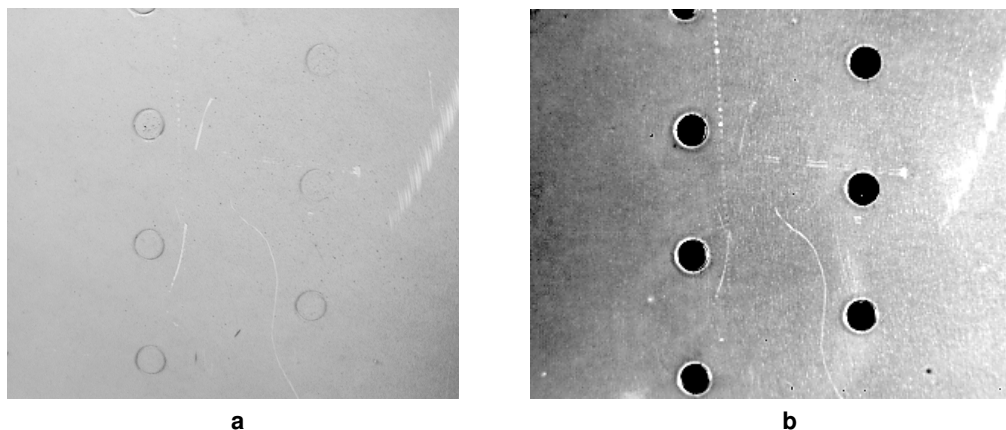
Figure 58 shows a comparison of a visual image of a portion of a JSTARS 707 wing and an IR image revealing corrosion on the fastener heads under the paint. Dark fastener heads indicate cadmium plate missing.

Figure 58 A visual (a) photo and an IR image (b) of corroded fasteners under paint in a Joint STARS 707 wing section.

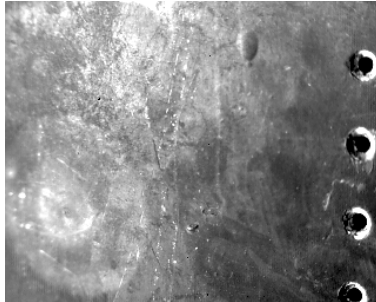
Metal Rework

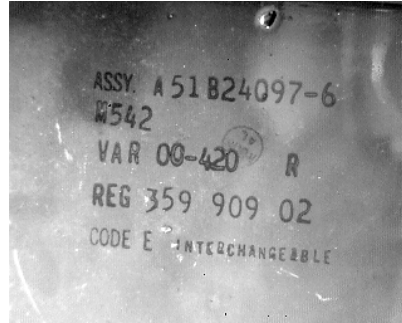
Painted Over Markings

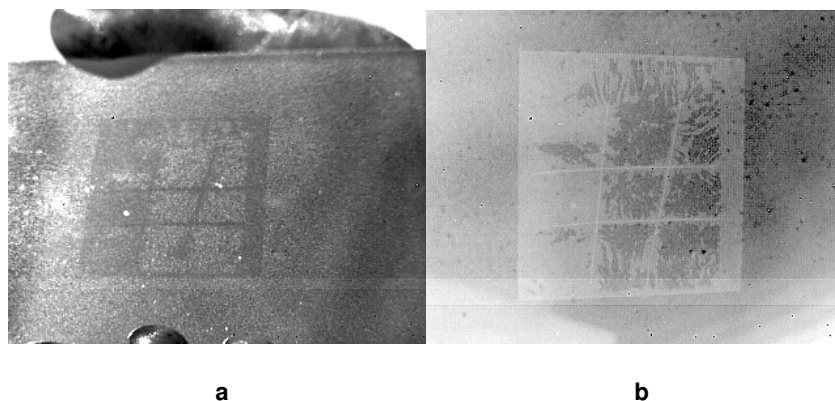
Figure 60 shows a collection of IR images of additional aircraft parts. Figures 61 and 62 shows IR images taken on a painted corroded coupon outdoor in daylight (cloudless day - summer). In Figure 61a, the first image is taken with indirect sunlight (shaded) with no artificial IR illumination. The corrosion pattern clearly comes through. The second image (Figure 61b) was taken with direct sunlight after the coupon was allowed to heat up. Although the corrosion image is still there, its contrast is reversed from the “cold” image. A similar situation

**Figure 61 Outdoor imaging of painted test coupon
a) in shade, b) in sun with heating (summer).**

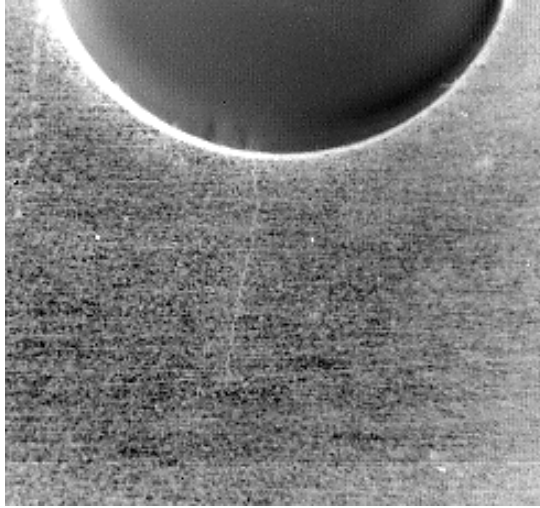
Figure 64 0.120" fatigue crack in 2024 aluminum bar imaged through 3.5 mil primer and topcoat.

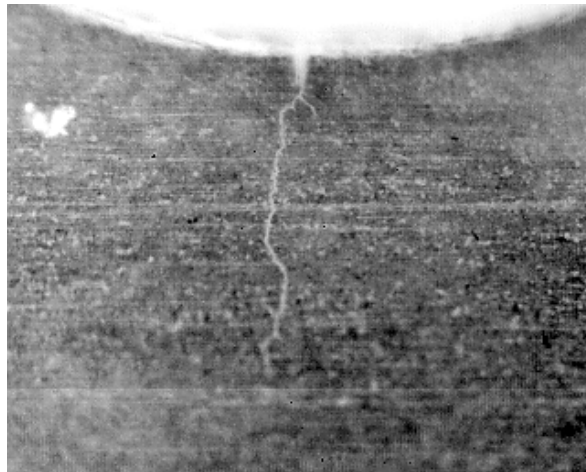
Figure 65 0.060" fatigue crack in 2024 aluminum bar imaged through 3.5 mil primer and topcoat.

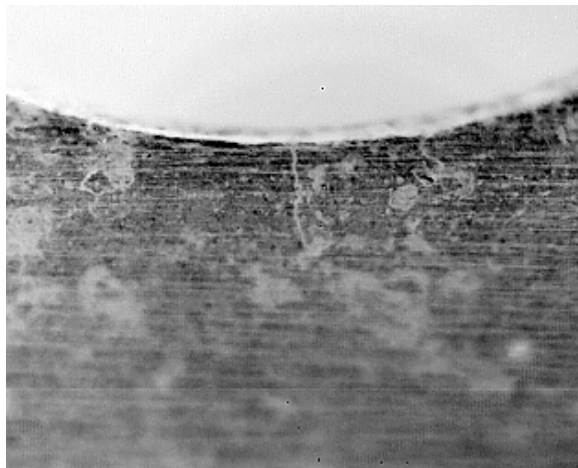
Figure 66 0.030" fatigue crack in 2024 aluminum bar imaged through 3.5 mil primer and topcoat.

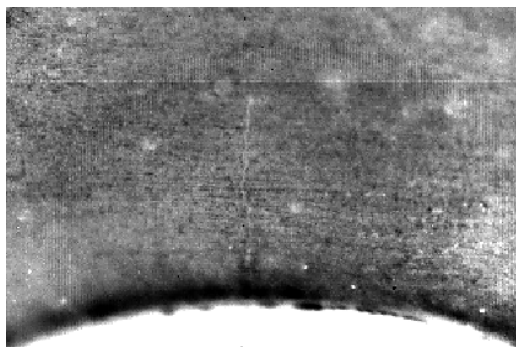
In addition to clean fatigue cracks, we imaged corroded fatigue cracks as well. Figure 67 shows a drilled aluminum plate with a fatigue crack exposed to salt fog, corroded, and painted. The crack is still clearly visible through the paint.

Figure 67 0.060" fatigue crack corroded, painted, and imaged with the IR system.

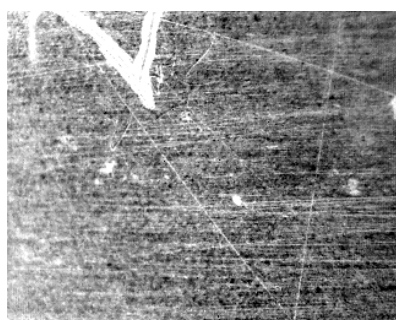
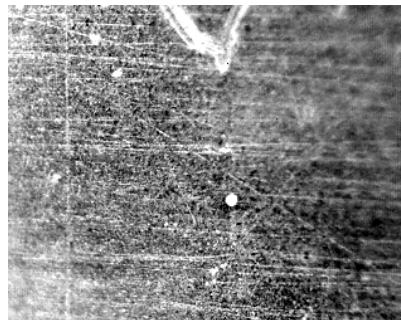
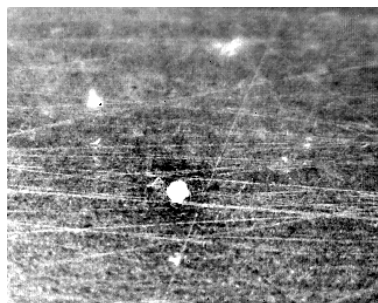
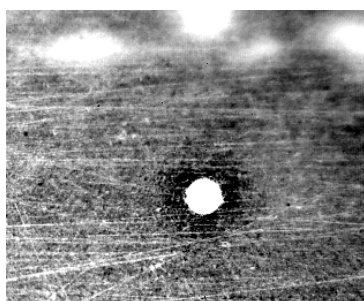
A series of electrical discharge machined (EDM) holes were drilled into aluminum bars and painted with milspec primer and topcoat (3.5 mil thick). These simulated pits were then imaged with the IR camera. Figure 68 shows a series of successively larger EDM pits imaged through the paint.

Figure 68 EDM simulated pits in 2024 aluminum imaged through 3.5 mil primer and topcoat.

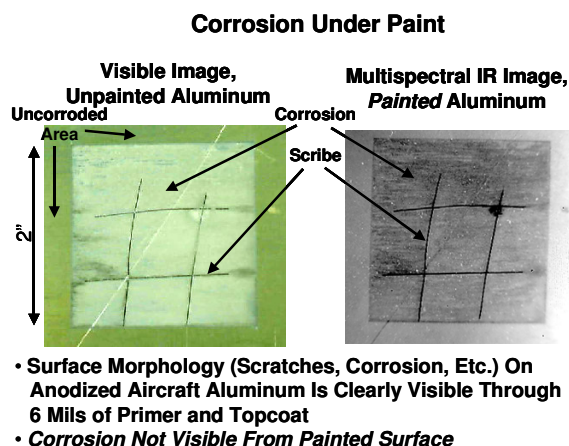
Studies to detect corrosion and other defects under coatings as a function of thickness were on going during 2002. Figures 73 and 74 show what a panel looks like before painting/coating and after painting under IR illumination. Note: The painted panels were completely covered with paint and the corrosion was not visible except under IR imaging. Figure 73 shows high clarity under 6 mils of paint, while Figure 74 exhibits clarity under 8 mils of primer and top coating, when viewed in the IR.

Figure 73 Corrosion on an unpainted panel on the left and the same corrosion under 6 mils (.006') of paint once the panel was painted.

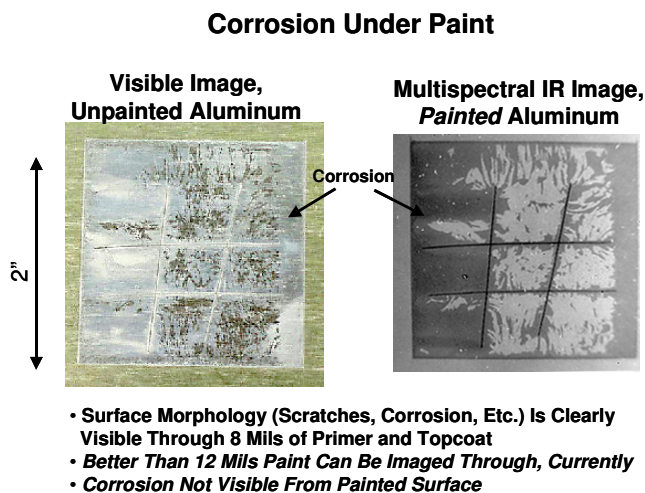
Figure 74 Corrosion on the surface of an unpainted panel on the left and the same corrosion under 8 mils (.008') of paint once the panel was painted.

These studies indicate that field produced corrosion should be detectable up to at least 8 mils of Mil-PRF-23377, epoxy primer and Mil-PFR-85582 TYI, polyurethane topcoat. This is important as many field aircraft have additional multiple coatings applied and in some cases far beyond specification requirements/limits.

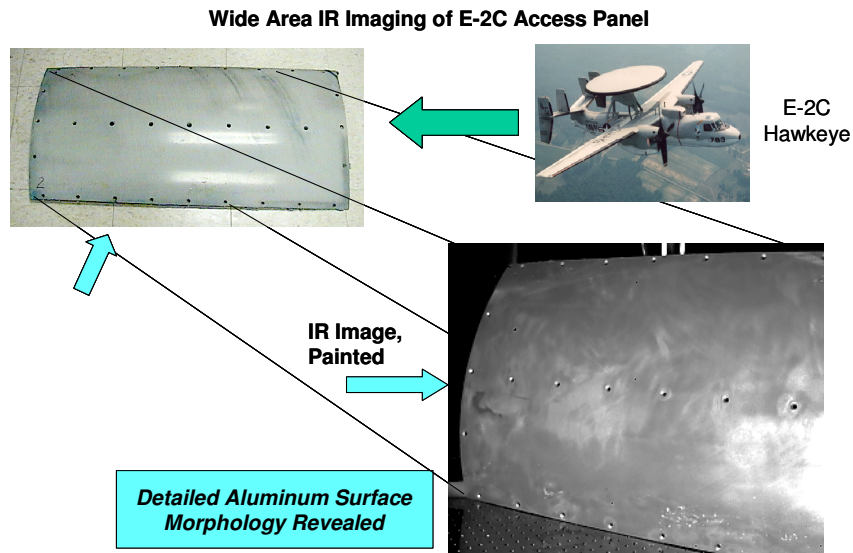
An E-2C production access panel was examined for corrosion and other defects. A general part survey was made first, as shown in Figure 76. As can be seen in Figure 76 potentially defective and/or discrepant areas can be seen by demarcations. These areas are denoted by un-uniform color and outlines in the IR Image. This was initially thought to be all corrosion related, however, it was later determined that upon close microscopic examination of the actual organic coating porosity was the problem. This can be seen in the second photograph of Figure 77.

Figure 76 Photographs of the overall panels as taken from an E-2C. The first photo shows the painted panel; the second is a picture of an E-2C; the third photo shows the panel image taken under IR.

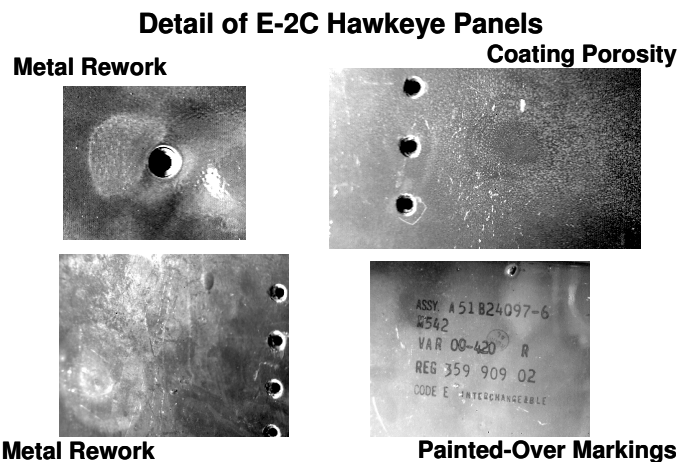
Figure 77 shows a more detailed and up close survey of the panel depicted by Figure 76. Metal rework can be seen in the first photograph. This rework is most likely the result of previous corrosion that was at least partially cleaned up by sanding or abrading. The second photograph illustrates what coating porosity looks like under IR. This is not a surface effect on the aluminum substrate and hence IR may also be a good tool to investigate coating quality as it relates to spray techniques and flow prior to setting up. The third photograph in Figure 77 shows another area where rework has taken place. The fourth and last photograph was an old part

marking under the top coat. The assembly number and even the individual inspector's stamp can be clearly seen. This capability could well help in a future failure investigation. Normally this information is virtually impossible to obtain under a painted part by other economical means.

Figure 77 Details of an E2C Panel in various locations around fastener holes plus a hidden ink stamp part number and an inspection stamp marking.

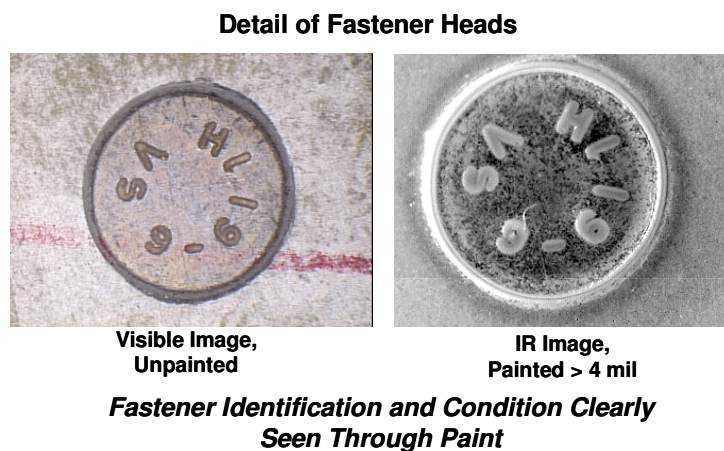
Figure 78 shows a standard aircraft Hi-LoK® Part Number HL19-6 manufactured by Fairchild Industries, as indicated by the VS on the fastener head. As can be seen the IR Image, which was taken under 4 mils (.004") of paint clearly shows the applicable part number and manufacture designation.

Figure 78 Hi-Lok® fastener head under visible light and under IR looking though 4 mils (.004") of paint. The part number can be clearly seen under the organic coating under IR illumination.

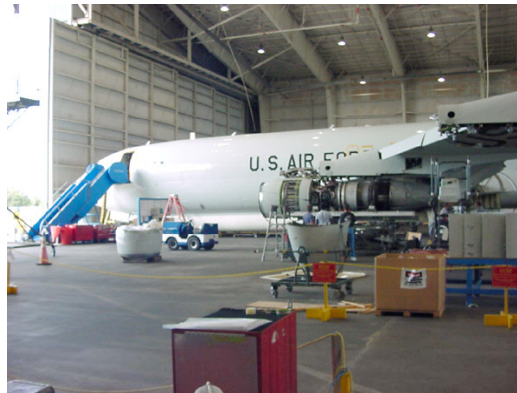
- Facilities at Melbourne, FL
- JSTARS Program
- Refurbishes Old 707s
- IR Survey Made in Direct Sunlight
- 707 Shown Here was Rejected for Excess Corrosion

Figure 97 Joint STARS aircraft in hangar during maintenance

It must be noted that this aircraft is no longer in service and was decommissioned due to corrosion around fasteners and other locations on the wing. Early detection could have saved this aircraft, which is now a complete loss to the Air Force inventory.

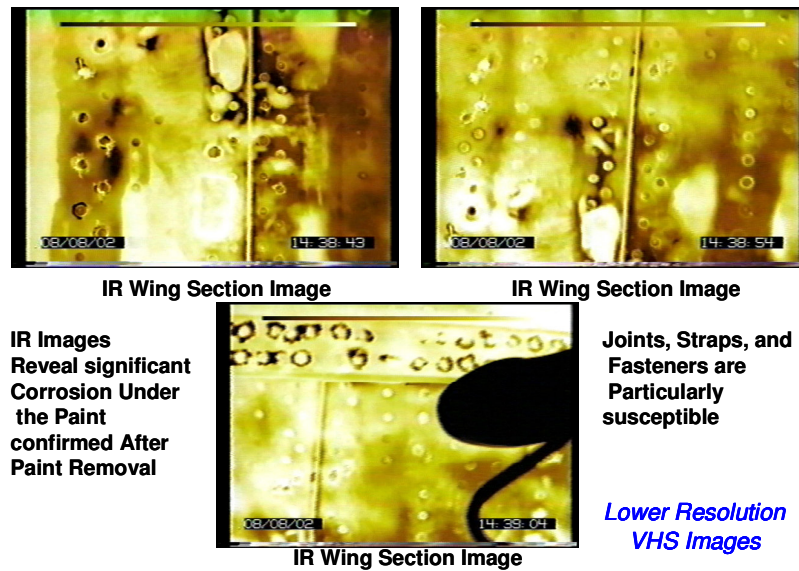
Figure 98 shows some of the painted locations that were surveyed for corrosion under the coatings by the IR camera system. As can be seen in the above photographs very little corrosion can be observed on the painted surface, which is usually indicated by corrosion deposits and peeling paint. The photographs in Figure 99 on the show what the corroded metallic surface looks like below the surface of the paint.

Figure 99 Corrosion is indicated by dark areas around fasteners. Lines of sealant can be seen in all photographs.

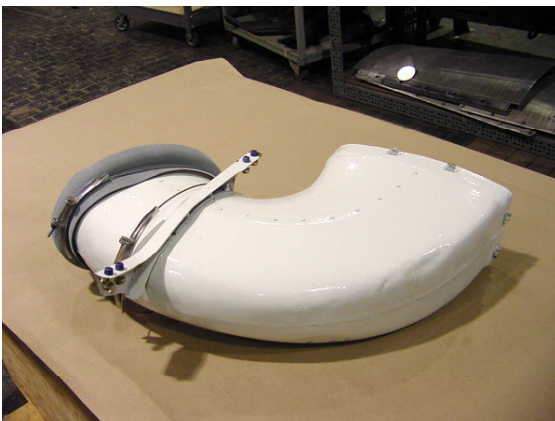
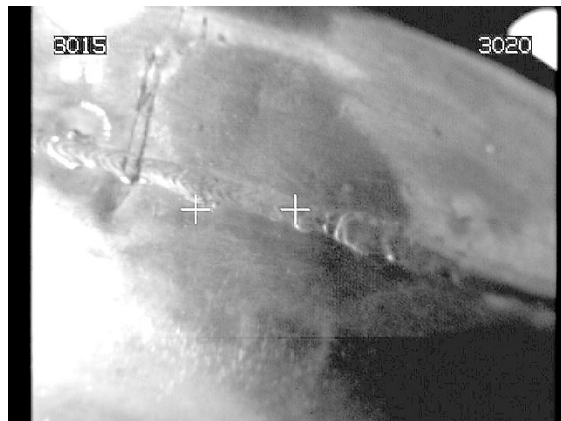
Figure 102 Welded duct from Bearcat. Photograph No. 1 shows white paint and photograph No. 2 shows weld area and corrosion that was reworked/abraded under the painted surface

The photographs in Figure 102 show a typical Bearcat environmental control system (ESC) duct that has been welded in at least two locations, as shown by the lower photograph. As can be seen from the top figure, the duct has been painted and the coating is most likely a coating of primer, MIL-PRF-23377 TYI and a top coated with MIL-PRF-85285TYI Gloss Insignia White Color No.17925. The lower photograph shows the aluminum surface of the ECS duct, which has been most likely abraded, prior to painting. The abraded area is located in the center of the photograph and is a little darker than the surrounding area. These figures were snap shots taken digitally from a movie that was made during the real time corrosion survey. Note: Two movies were made. One of the movies was output from the IR camera feed into the camcorder and the other movie was just the standard illumination feed into the camcorder much the same way a home movie is made.

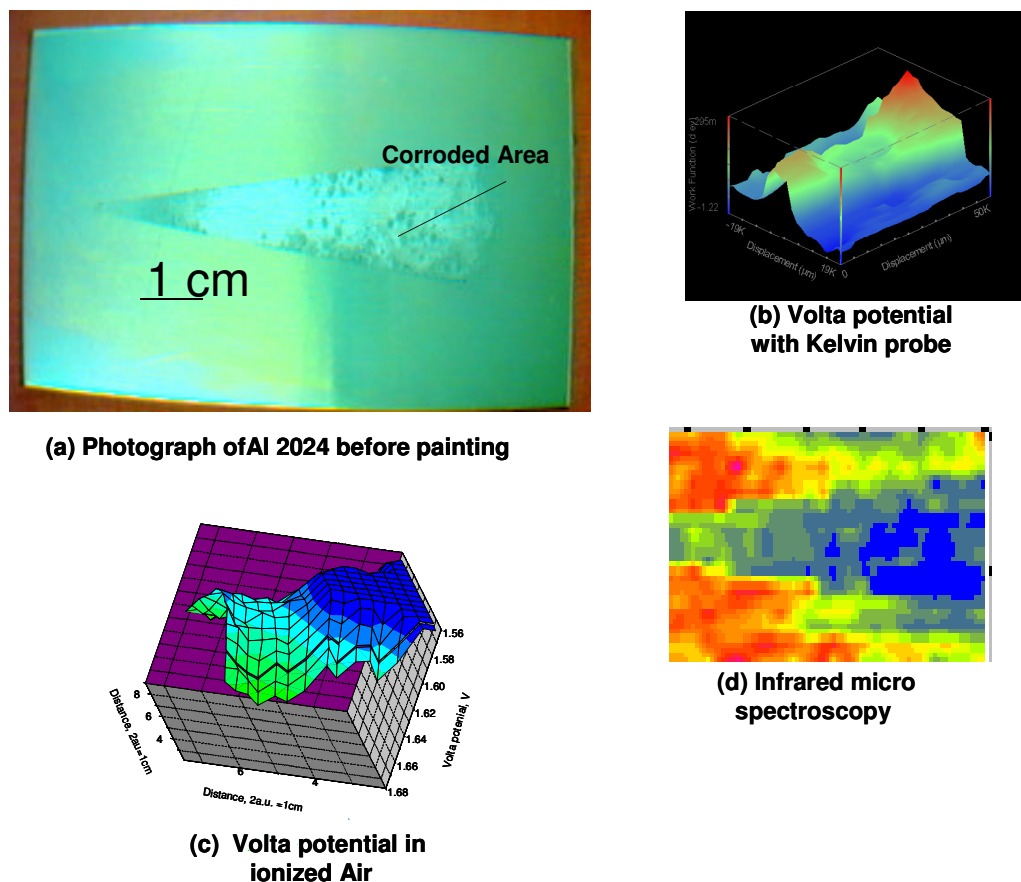
Fig. 132 Detection of corrosion under 3.6 mil paint layer using three different scanning techniques.

A comparison of the two Volta potential methods and the infrared microspectroscopy (IMS) method for detection of corrosion under a film of a defect-free paint is given in Figure 132. The first image shows a photograph of an AA 2024 sample with a visible corroded area, prior to being painted. The sample had been chromate conversion coated. The sample was masked leaving a wedge shaped area exposed. The sample was first covering with 0.1 M HCl and then placed in a humid atmosphere for two weeks. The masking was then removed, the sample washed and dried, and the surface painted. The photograph of the sample Figure 132a, shows the area that was scanned using the three different techniques.

The SKP results are shown in Figure 132b. The map of the scanned surface obtained by Volta potential measurements in ionized air is shown in Figure 132c. The 3D map of Volta potential shows the difference between the corroded and non-corroded areas. The last image in Figure 4d represents the results obtained by infrared microscopy. The intensities of the peaks at 1042 and 2086 cm^{-1} were used to generate the 2D plot. It exhibits the same locations of corrosion, as the two Volta potential techniques. All three techniques can therefore be used to detect of corrosion under paint.

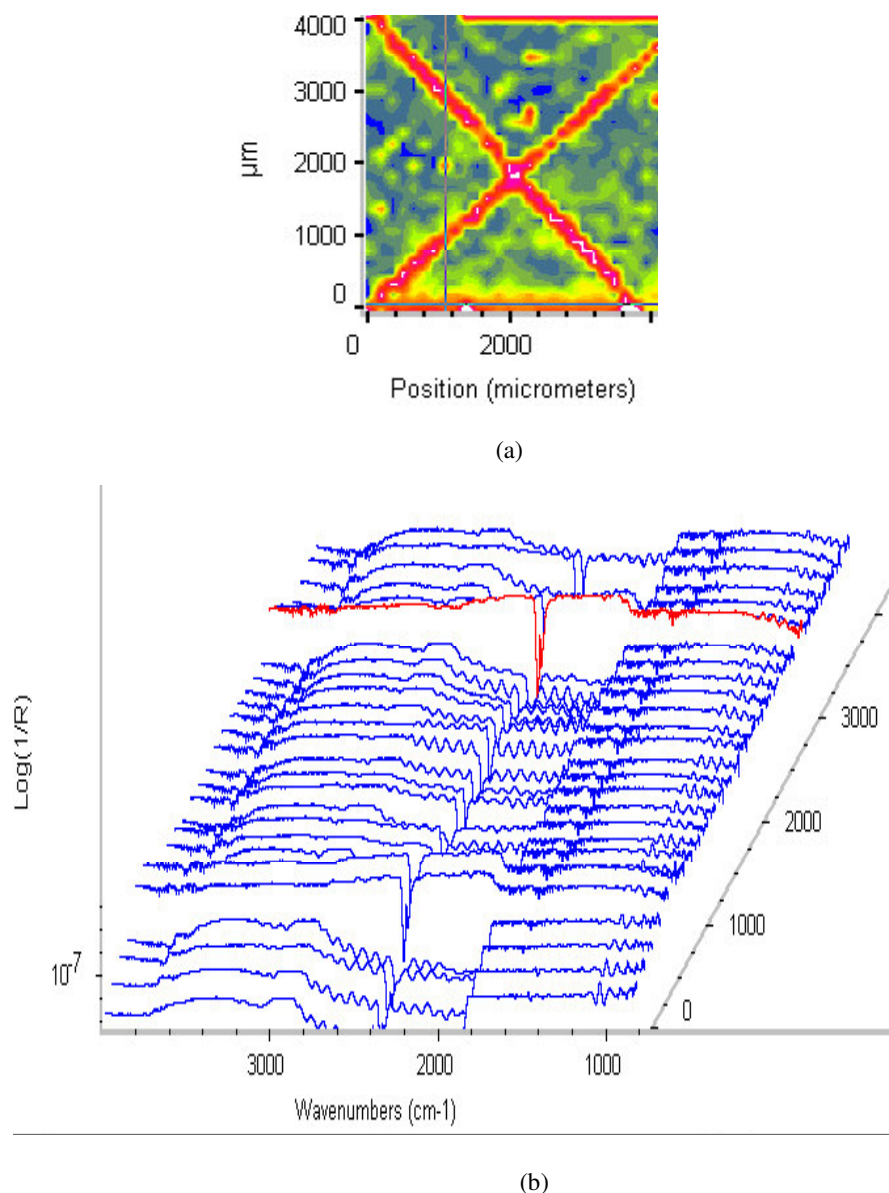
Fig. 134 IMS of painted AA2024 scribed before corrosion. (a) Map for the overall intensities of absorbance spectra; (b) absorbance spectra along the line shown in (a).

An example of the detection of corrosion under a paint layer using IMS is given in Figure 134. The sample was a scribed, chromate conversion coated AA2024, which was then exposed 3 days to humidity, masked, exposed two weeks in a humid atmosphere after covering with 0.1 M HCl , washed, dried, and finally painted with a 3.5 mil thick paint layer. The spectrum for a corroded area showed a typical window between 1850 and 2850 cm^{-1} which makes it possible to see through the paint (Figure 134b). The 2D map (Figure 134a) was derived from the overall intensities of the absorbance. This mode of plotting clearly identified the areas of corrosion. The differences were greatest at heavily corroded sites that can be seen in Figure 134b for the 5th and 6th and the 22nd and 23rd spectra which were recorded over the scribes taken along the line in Figure 134a

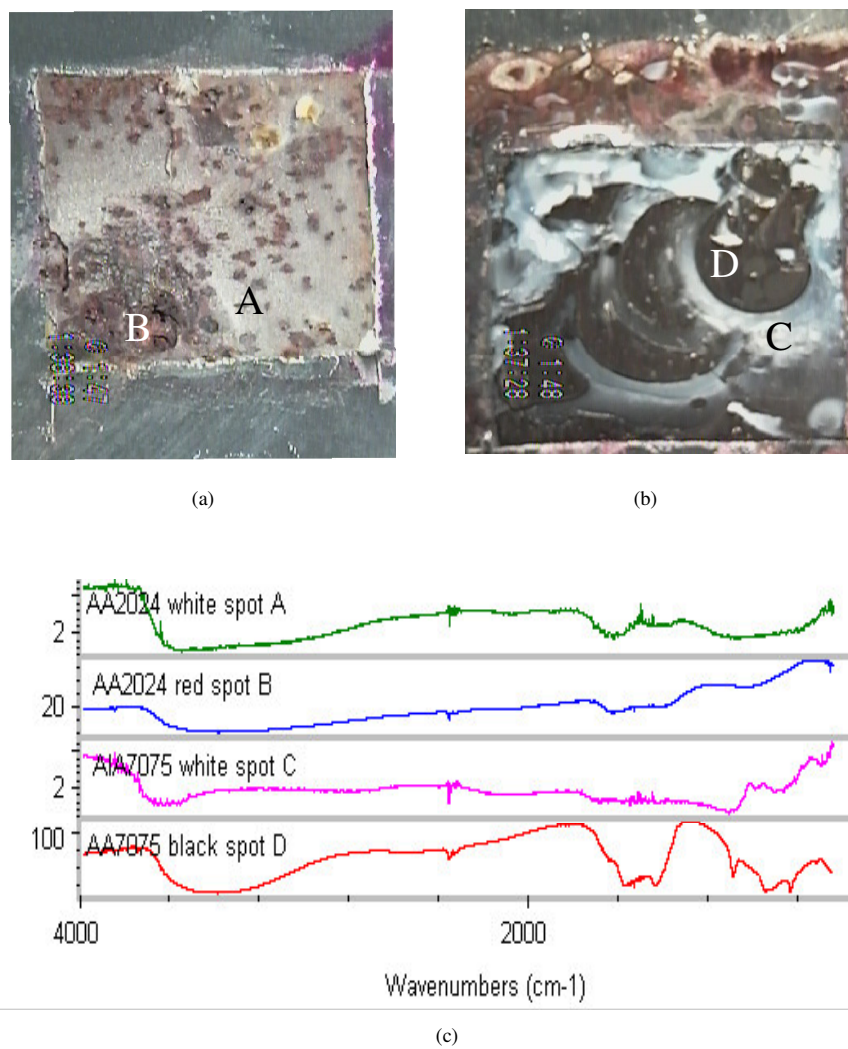
Figure 137 IMS on the corroded Al alloys AA2024 and AA7075. Video images of the samples after 12 weeks corrosion in gel: (a) AA2024; (b) AA7075 and corresponding reflectance spectra (c).

The appearances of the samples after removal of the gel are shown in Figure 137a and b, respectively after 12 weeks of corrosion in a humid environment covered with gel. The appearance was quite different for the two alloys. In both cases the pH indicator disappeared. The alloy AA7075 produces a cloudy white corrosion product.

time when exposed to air. The AA7075 had quite a different appearance, showing white and black areas on the surface. Corrosion had also spread into crevices under the tape, and had a similar red coloration seen in the AA2024 pits and also turned black with time.

Figure 137c shows IMS spectra taken over different spots on the corroded alloys. There is a marked difference in the spectra between the black and the white spots for the alloy AA7075, while for the AA2024 the difference is due to intensity variations of the reflectance spectra. Preliminary analysis of AA70 75 ascribes the peaks at 1400 to 600 cm⁻¹ to a zinc aluminum carbonate [2]. A broad absorption region at 3400 cm⁻¹ corresponds to an OH⁻ starching group that can be seen in all the spectra.

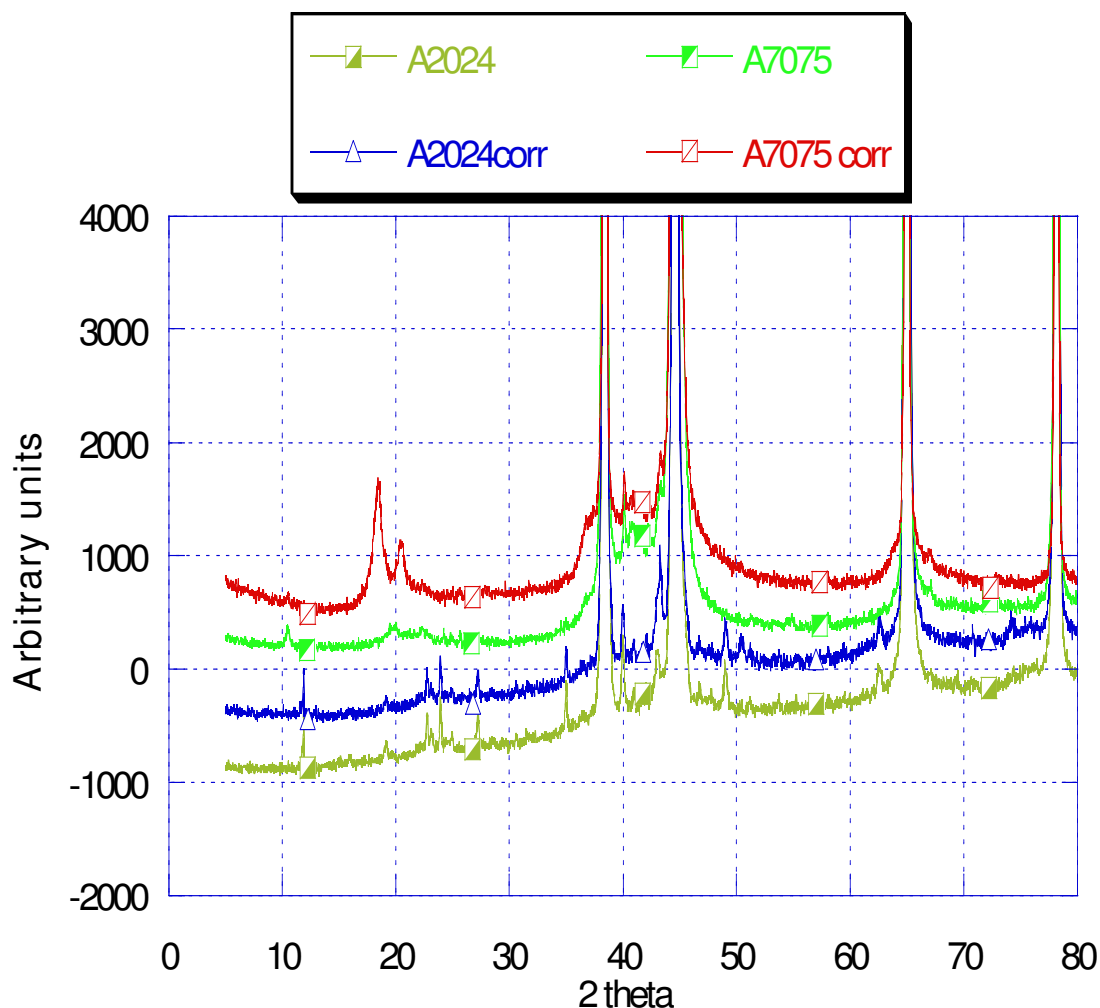
Figure 139 XRD patterns for AL alloys AA2024 and AA7075 corroded in 1M NaCl gel and for the corresponding non corroded alloys.

Figure 139 shows XRD data for corroded and uncorroded alloys AA2024 and AA7075. All patterns show strong peaks for Al, and smaller peaks for intermetallics. Distinct peaks for 2θ of 18.429° and 20.523° were observed when the corrosion product on AA7075 was present. The product can be ascribed to aluminum hydroxide (Gibbsite) $\text{Al}(\text{OH})_3$. However, the carbonate that was indicated from the IMS data and has been observed [3] with Zn-Al alloys could not be seen probably because of the small quantities present.

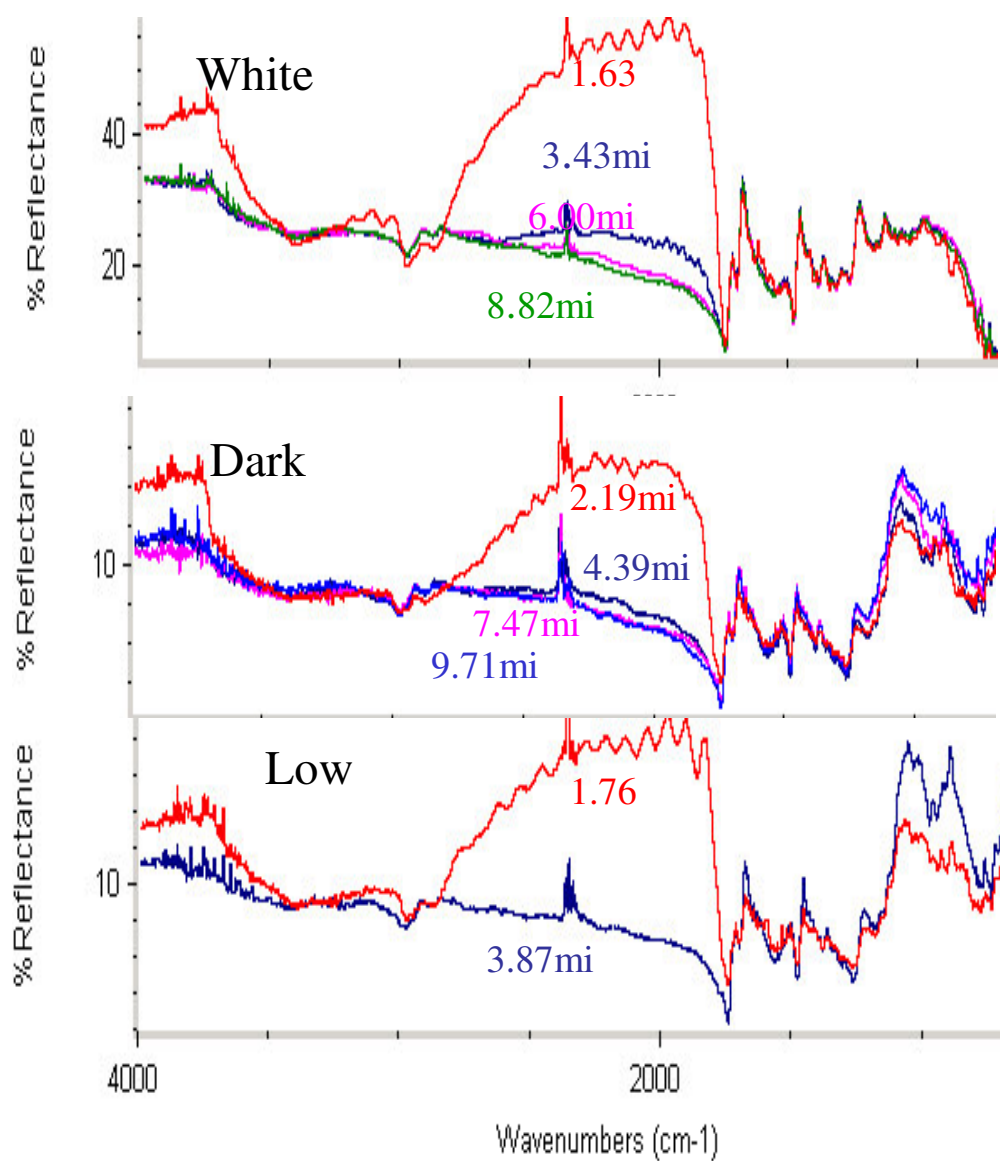
Figure 140 Effect of paint thickness on reflectance of painted non-corroded Al alloys 2024-T3.

Results Year 2002 – Figure 140 represents the effect of paint thickness on the reflectance of non-corroded samples. Each spectrum shows an IR transparent window from 1800 to 2700 cm^{-1} giving a maximum around 2000 cm^{-1} ranging. This peak is obtained for all types of paint studied. Comparison of different types of paint for the same substrate shows that the spectral reflection decreases in the order, Insignia White, Dark Camouflage and is the lowest for Dark Camouflage Type II Low IR. There are also less pronounced reflectance peaks at 3100 and 3800 cm^{-1} observed for the thinner top coating. The spectra for three paints are very similar except that Dark Camouflage and Low IR paints have the higher intensity reflectance peaks for thicker coatings at the lower frequencies (1050 and 800 Hz). The intensity of the peak decreases with the paint thickness.

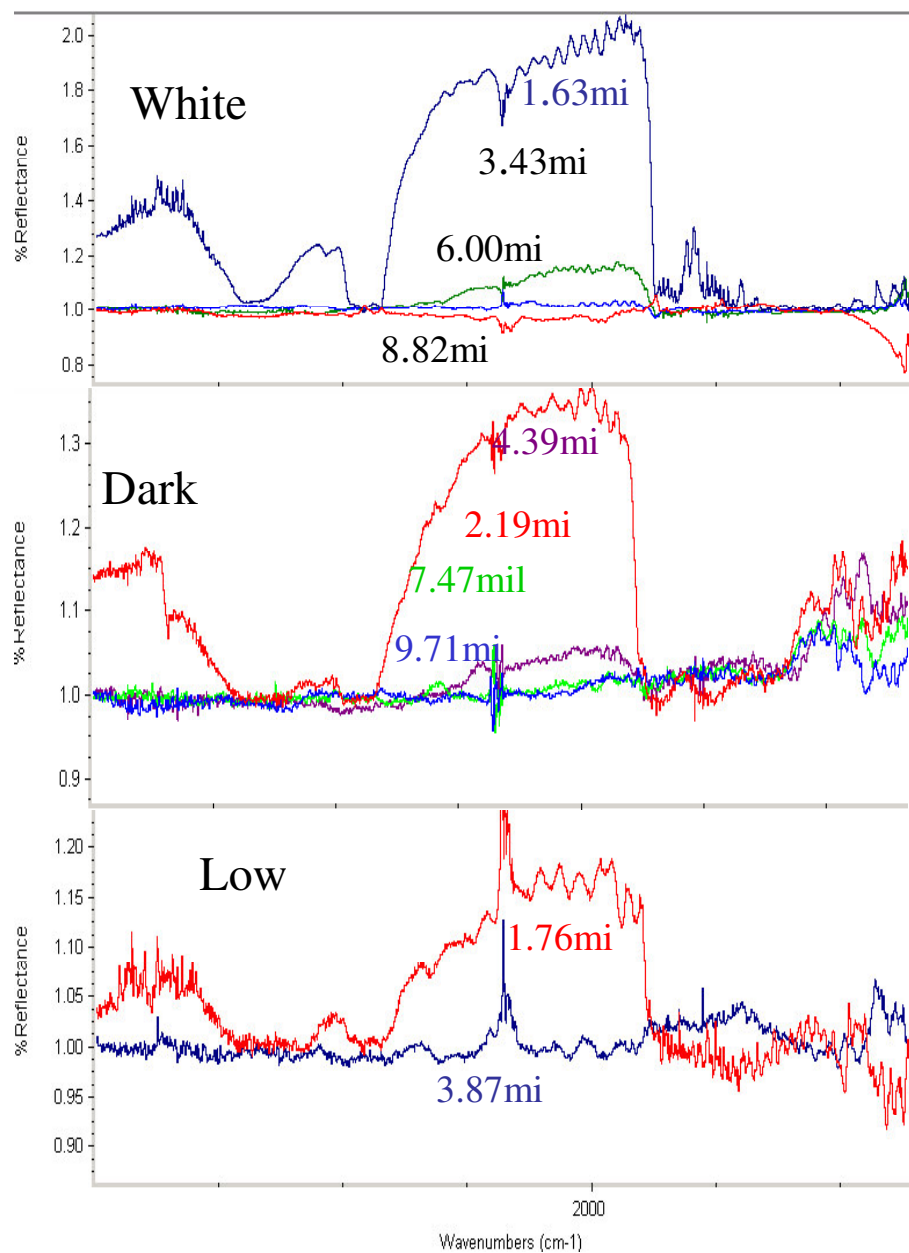
Figure 141 Reflectance spectral ratio of painted non-corroded/corroded Al 2024- T3 samples.

Corrosion produced changes in reflectance. The changes were determined by applying a data analyses technique to calculate the ratio of the average reflectance of uncorroded panels relative to corroded panels. The reflectance spectra were baseline corrected at 1250 cm^{-1} within a spectral region where the paint is opaque. Figure 141 represents the calculated spectral ratio for three different paint systems. The ratio spectra show peaks higher than 1.0 in transparent regions. When the intensity is close to 1.0 the thick coating are opaque. However below 1800 cm^{-1} there are definite indications of reflectance which differ with corroded and uncorroded surfaces.

The analysis shows that very small signal, spectral ratio close to 1.0, is obtained for 8.82 mil Insignia White, 7.47 mil Dark Camouflage, and for only 3.87 mil thick Low IR paint at the frequency region around the reflectance peak of 2200 cm^{-1} . A more detailed spectral analysis is needed for Low IR paint below 1800 cm^{-1} (Figures 140 and 141) to characterize the behavior at the lower frequencies.

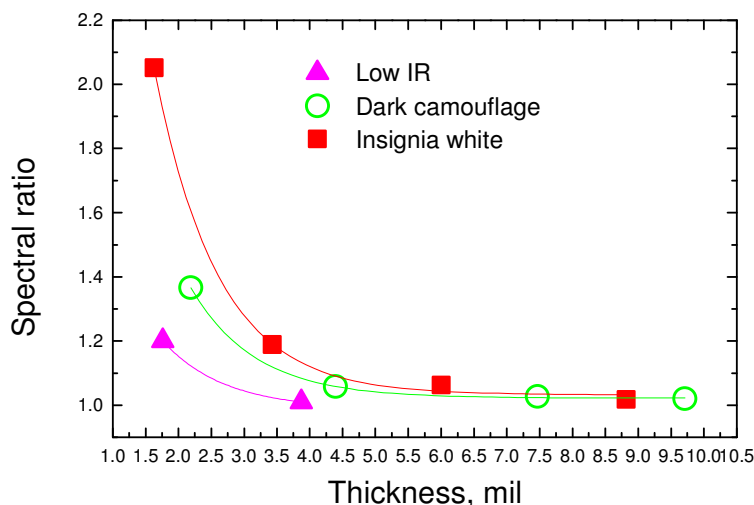
Figure 142 Reflectance spectral ratio vs. paint thickness for different paint systems.

The intensity for the prominent peak at the 2200 cm^{-1} is plotted against the thicknesses for the three paint system in Figure 142. The signal decreases with a thickness of the paint. The highest signal is obtained for the Insignia White topcoat. A lower one is found for Dark Camouflage and the lowest for Dark Camouflage Type II Low IR. Using the measuring procedure adopted reflection from the metal was detected for 6 mil Insignia White, 4.39 mil Dark Camouflage gray and 1.76 mil for Dark Camouflage Type II Low IR.

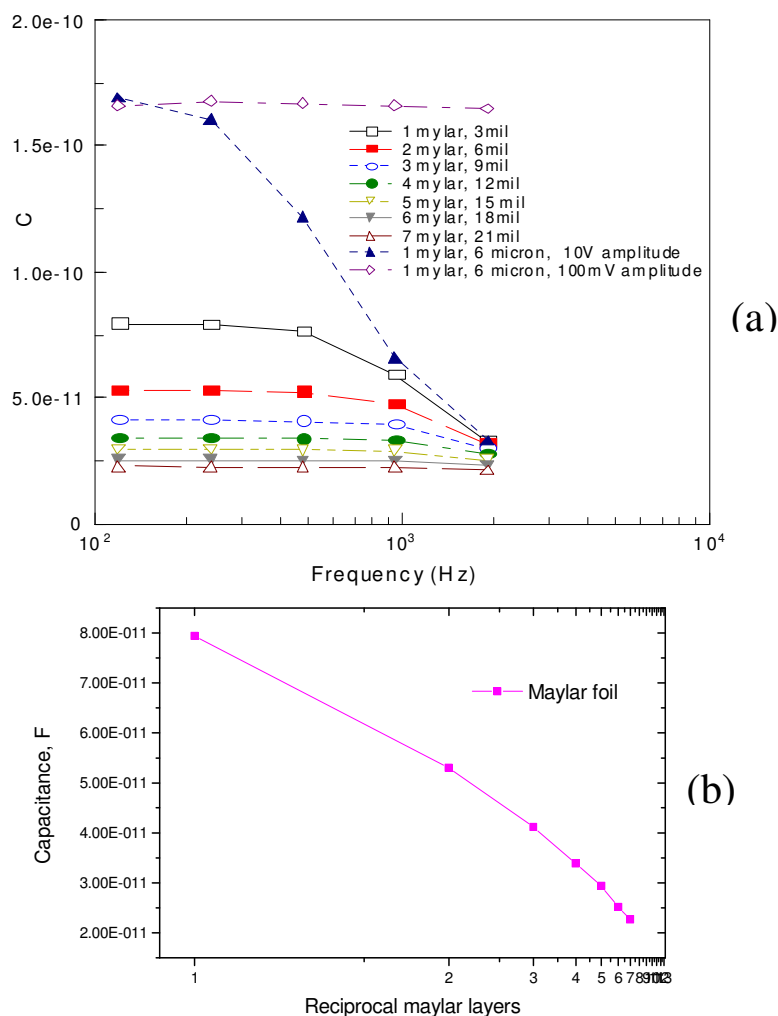
Figure 143 Impedance measurement of Mylar layers with a dry copper disk (3.14cm^2): (a) capacitance vs. frequency; (b) capacitance at 100Hz vs. reciprocal of the number of layers.

Figure 143a shows the capacitance in the frequency range 2000 to 100Hz for multiple layers of Mylar foil (3mil thick). Measurements were performed in a dry mode with the copper disk as a probe. The applied voltage amplitude was 10V for all layer thicknesses. Capacitance for very thin Mylar foil (6micron) obtained with 10V and 100mV amplitudes is given in the same figure. The 100mV curve is a flat line, while the 10 V curve has a sloping part in the high frequency region. The same behavior could be seen for the group of curves of the 3mil thick Mylar foil, where the thinnest layers have the slope. The comparison of the capacitance for multiple layers would be incorrect for the frequencies in the sloping region. A flat frequency response was therefore chosen for all comparisons.

The plot in Figure 143b shows capacitance at 100Hz vs. the number of reciprocal Mylar layers. A straight line is expected when the capacitance is plotted against reciprocal of layer thickness or number of layers. The expected straight line was not obtained. Reasons for the deviations could be due to the capacity loss because of the wiring or to the limitation of the instruments.

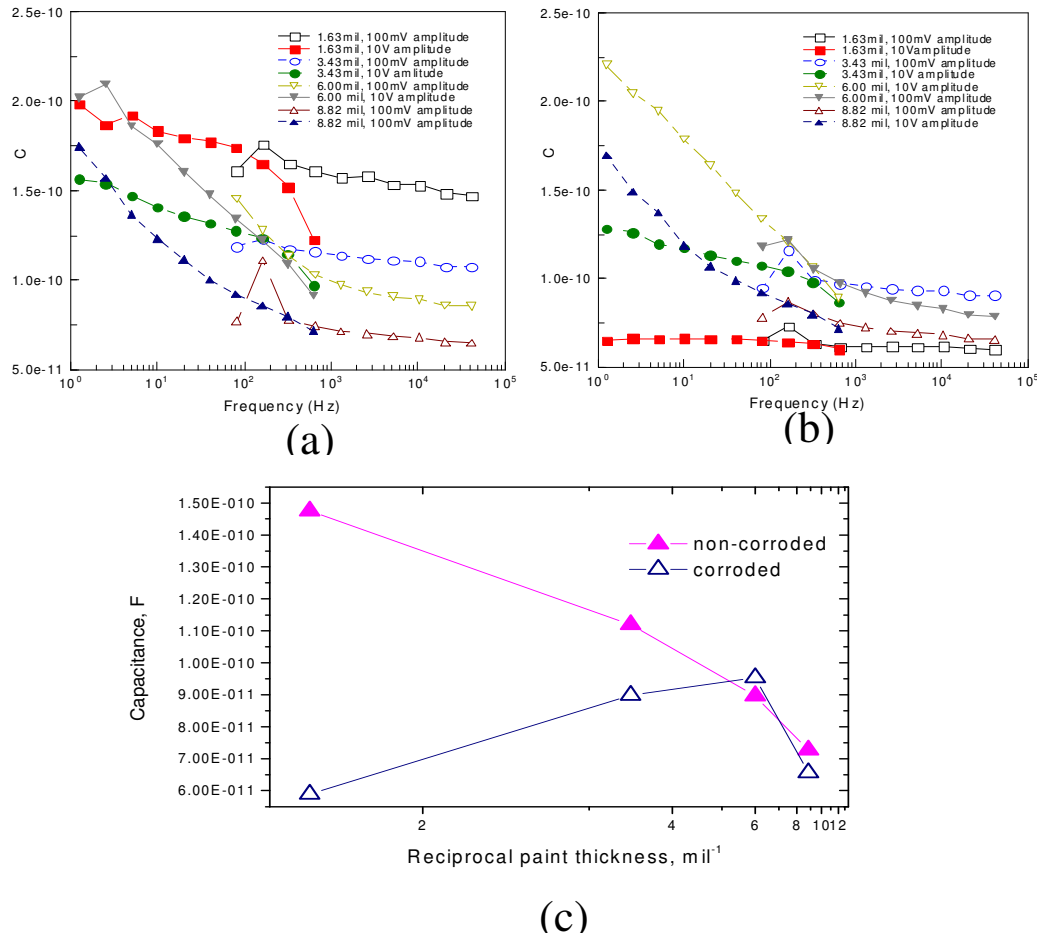
Figure 144 Impedance measurements of Insignia White paint on Al alloys 2024-T3 with dry copper disk (3.14cm^2): (a) Non-corroded; (b) Corroded; (c) Capacitance at 650 Hz vs. reciprocal paint thickness.

The copper disk probe in a dry mode was used for impedance measurements on painted panels. The results for White Insignia paint are given in Figure 144. Measurements were performed with two amplitudes, 100mV and 10V, in the frequency region from 6500 to 1Hz. Measurements at 60 Hz are always in error because of noise. Capacitance for non-corroded samples (Figure 144a) is decreasing with a thickness of the paint, while for non-corroded samples (Figure 144b) the thinnest paint has the lowest capacitance. A plot of the capacitance vs. reciprocal paint thickness (Figure 144c), gave the expected linear dependence for non-corroded samples, but non-linear curve with a maximum was obtained for the corroded samples. The obtained smaller than expected capacitance for thin paint layers on corroded samples, was probably due to the roughness of the corroded surface. The protruding corrosion product increased the gap between the probe and the aluminum reducing the measured capacitance. A similar behavior was observed for the Gray Camouflage and the Low IR paint.

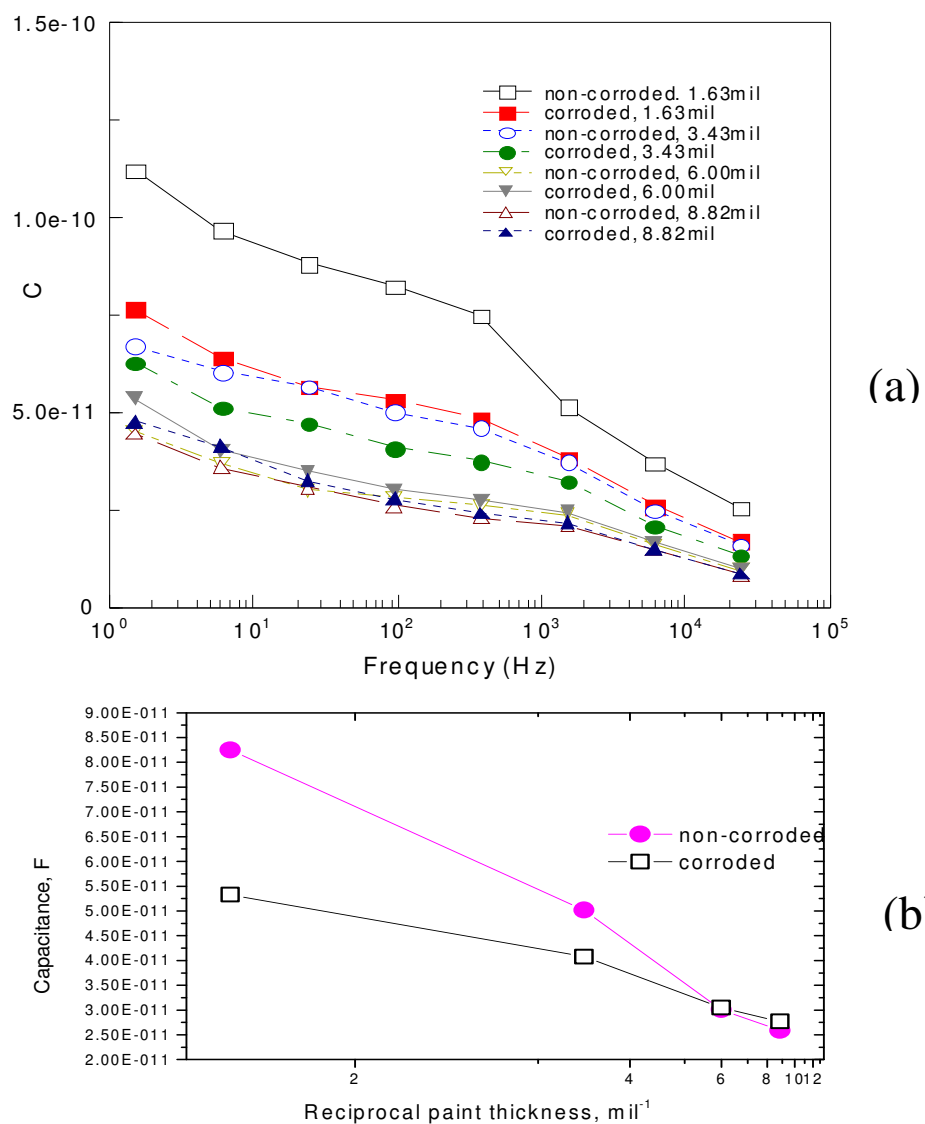
Figure 145 Impedance measurements of Insignia White paint on corroded and non-corroded Al alloys 2024-T3 with wet stainless steel hemisphere probe (0.2cm^2): (a) Capacitance vs. frequency; (b) Capacitance at 1500 Hz vs. reciprocal paint thickness

Using the gel as a wetting agent reduces this effect but does not overcome the non-uniformity of the painted surface. White paint with a gel and a stainless steel hemisphere as a probe having a contact area of 0.2cm^2 , are given in Figure 145. Measurements were made at frequencies from 2000 to 1Hz with a voltage amplitude of 10V. It is seen that capacitance of both corroded and non-corroded samples (Figure 145a) decreases with the paint thickness. Capacitance at 1500 Hz for the corroded and non-corroded samples is plotted vs. reciprocal paint thickness (Figure 145b). Significant differences for the corroded and uncorroded samples was again observed up to 4mil indicating that the thinner films were not changing in a predicted manner and was not only due to surface roughness producing an air gap between the sample and the probe.

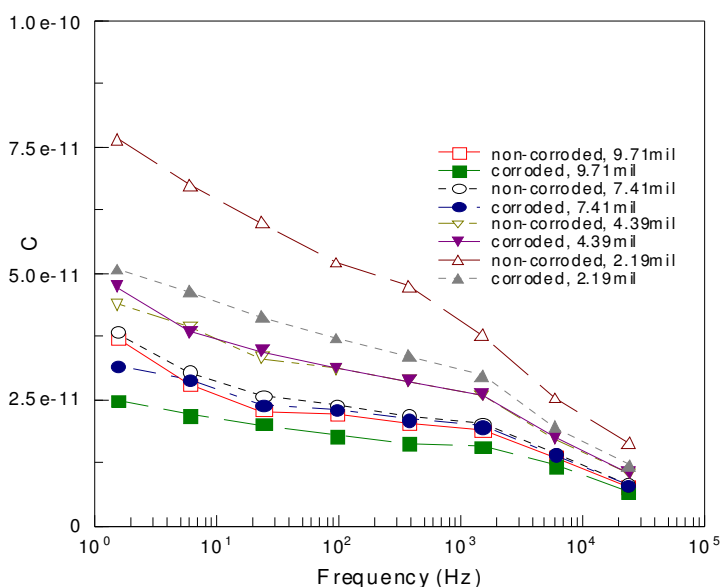
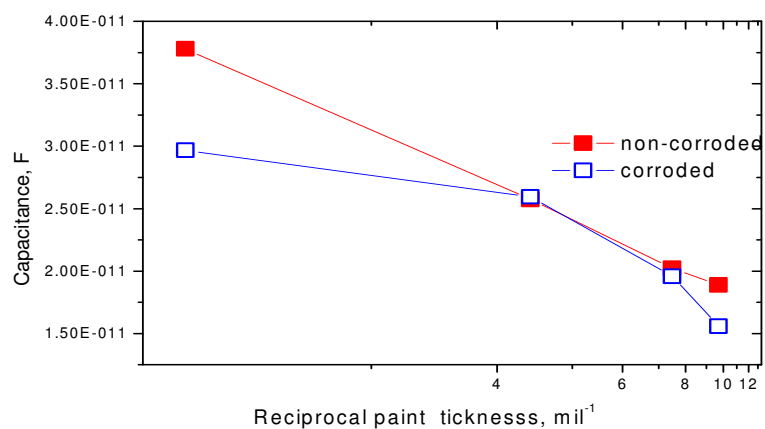
Figure 146 Impedance measurements of Dark Camouflage paint on corroded and non-corroded Al alloys 2024-T3 with wet stainless steel hemisphere probe (0.2cm²): (a) Capacitance vs. frequency; (b) Capacitance at 1500 Hz vs.

Similar results are obtained with Dark Camouflage and Low IR paint system shown in Figures 146 and 147, respectively. The capacitance difference for corroded and uncorroded samples was again seen up to 4mil (Figure 146b and Figure 147b).

More research is needed to develop this technique to measure the small changes due to corrosion for the thicker coatings. There are several possibilities for improving the impedance measurements to locate corrosion under the thicker paint coatings with the higher impedances. These include the design of a fully protected shielded probe and connections to reduce stray capacitance.
